TWIN STATE ENVIRONMENTAL CORP.

March 17, 1997

RE: Peyratt Spill, Swanton, VT
TSEC Project # 97-008 972148

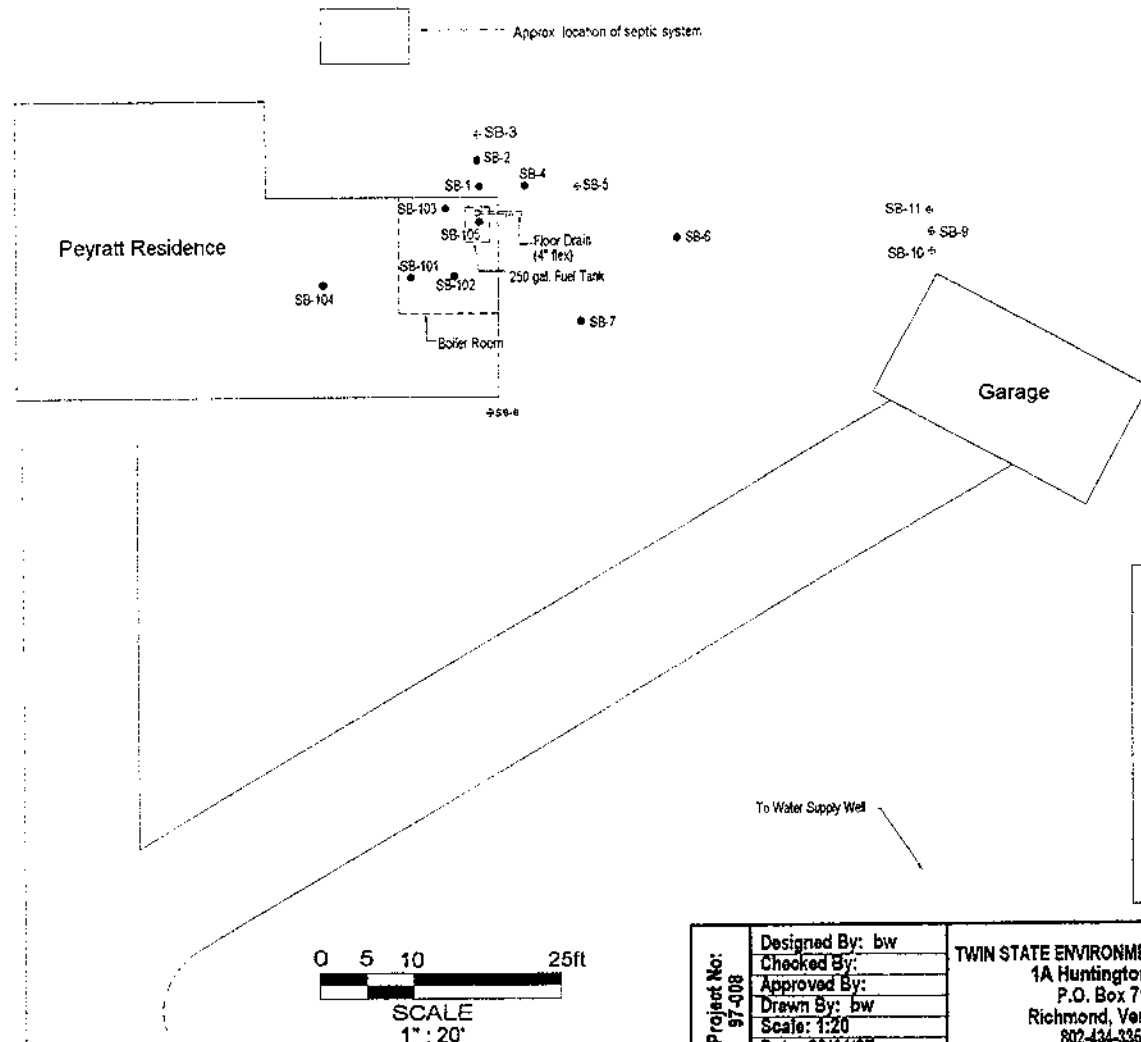
Project No: 97-008	Designed By: bw	TWIN STATE ENVIRONMENTAL CORP. 1A Huntington Rd. P.O. Box 719 Richmond, Vermont 802-434-3360	FIGURE 2 SITE PLAN Peyratt Residence February 1997 Swanton, Vermont
	Checked By:		
	Approved By:		
	Drawn By: bw		
	Scale: 1:20		
	Date: 02/11/97

The installation of the SVE system was performed on February 18 and 19, 1997. The SVE unit consists of a 1.0 horsepower regenerative blower plumbed to a manifold which controls flow rates and vacuum to the three (3) vapor extraction lines (SV-1, SV-2, and SV-3). Each extraction line was installed to pull vapors from two (2) different vent wells. A moisture separator was added to the system to capture any water that might be drawn from the vent wells. A schematic of the system is presented in **Figure 2**.

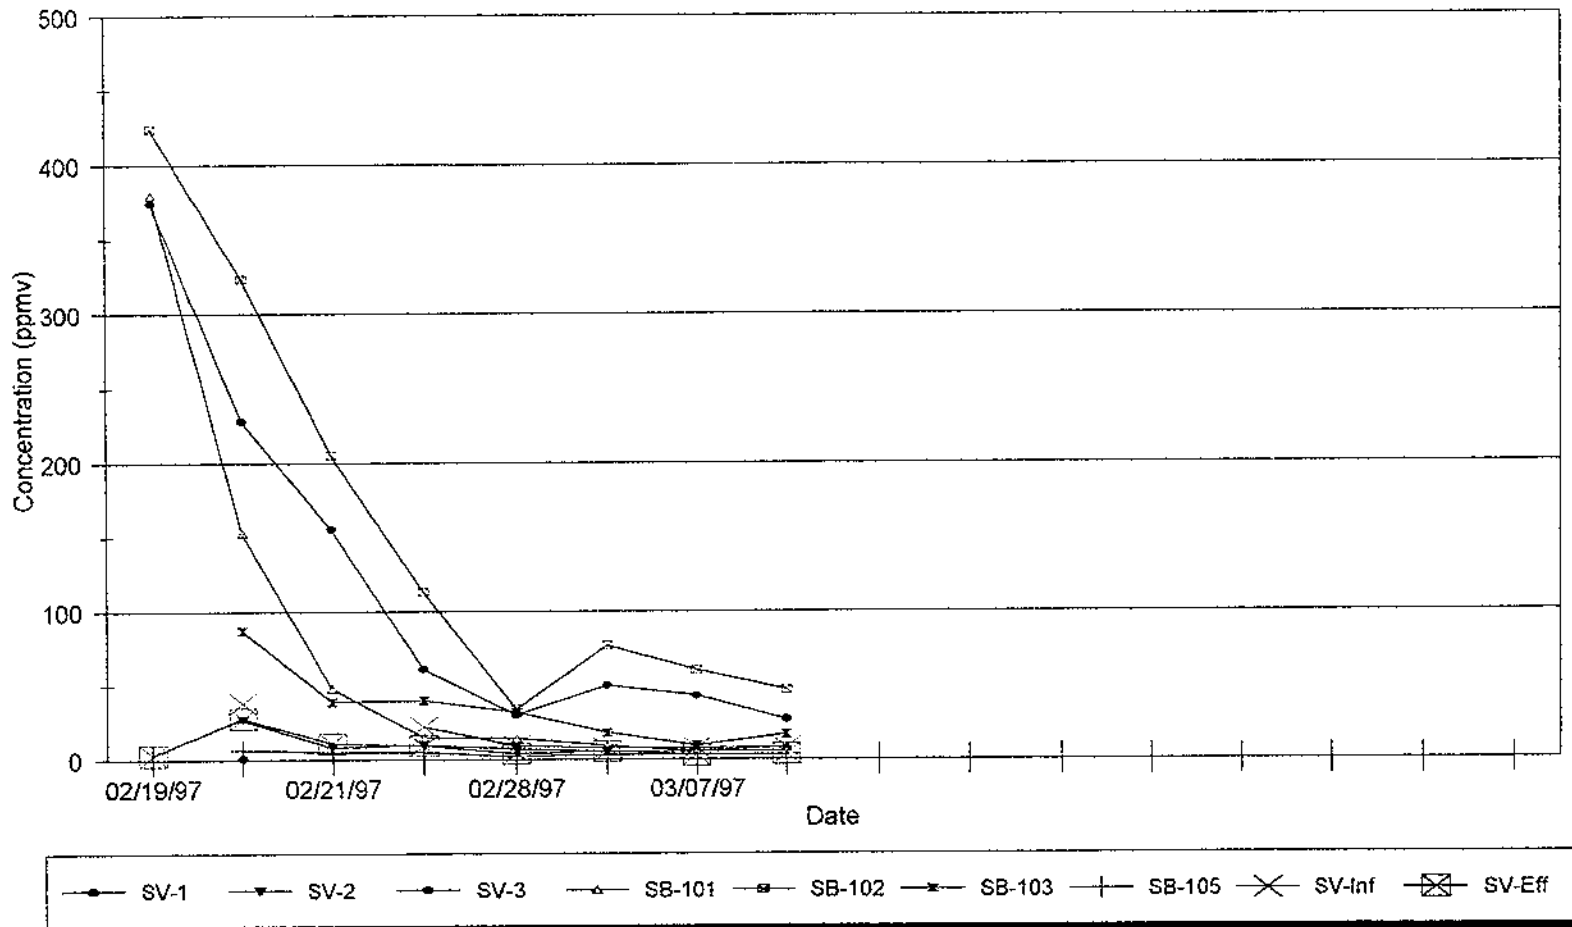
FIGURE 4
Soil Venting Trend Analysis-p1.

PID concentrations taken since the installation of the SVE are presented in **Table 2** and graphically presented in **Figure 4**.. The concentrations show a continuous decline during the operation of the SVE system. However, the area of highest concetration remains in the middle of the laundry room under the slab.

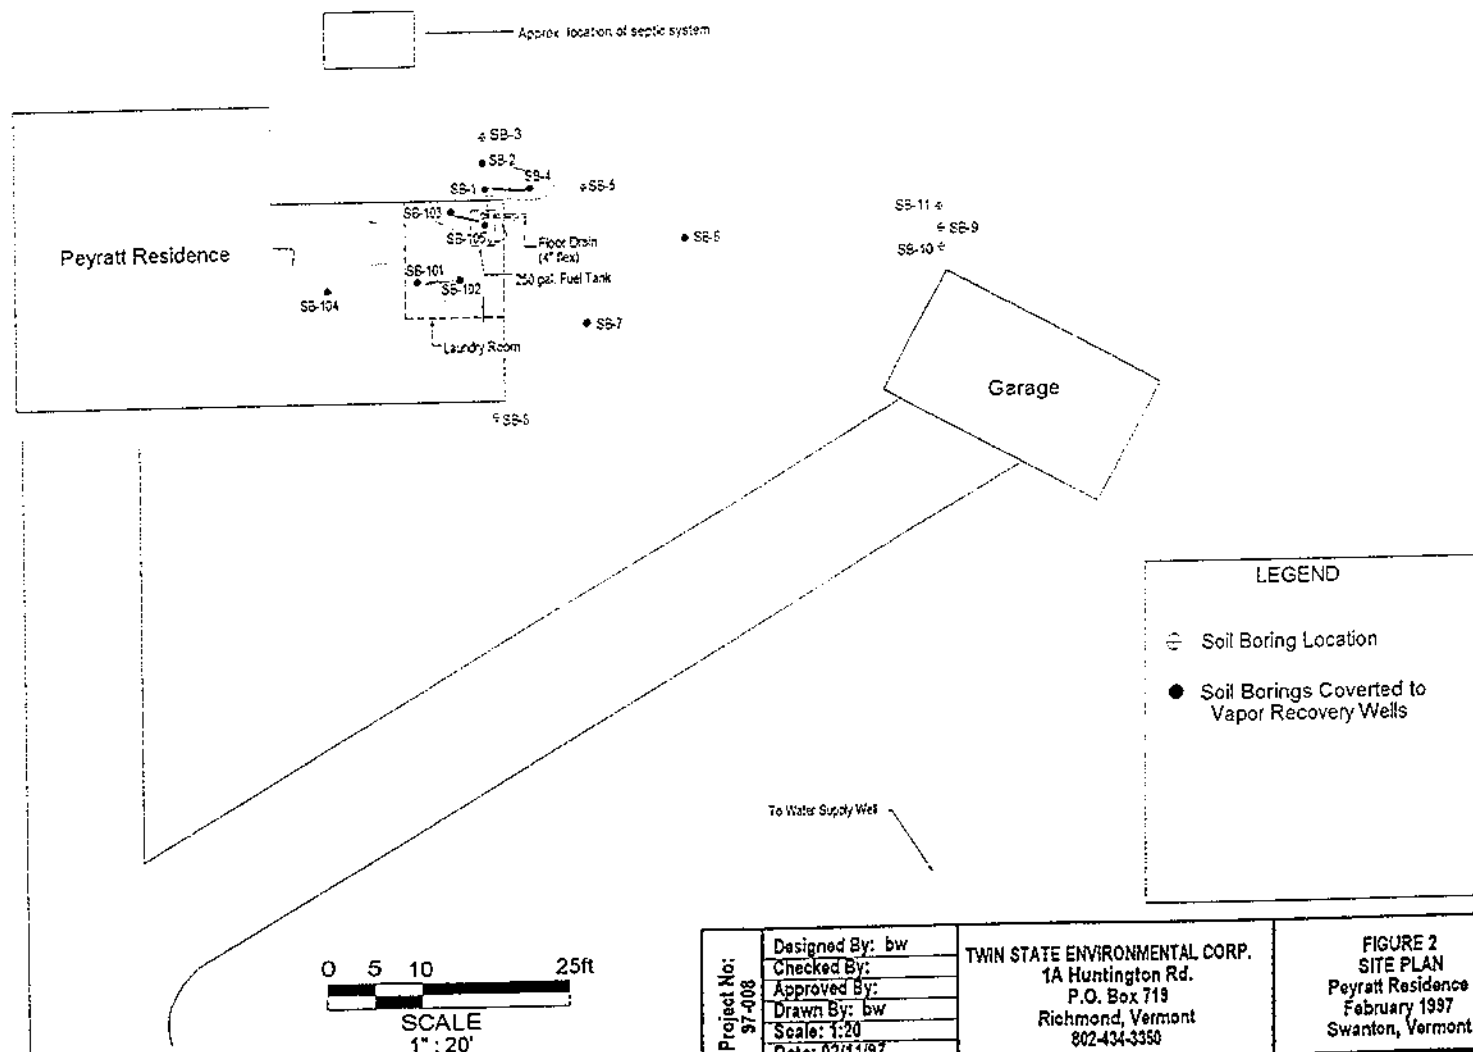
On Tuesday February 4, 1997 TSEC advanced four boreholes inside the lower level of the home near the oil tank. Three of the boreholes were located in the laundry room and one was in the crawl space near the center of the home. Please refer to Figure 2 for approximate locations. Additionally eleven borings were advanced outside of the home at locations shown on Figure 2. Headspace analysis was performed on soils retrieved from the boreholes and screened with a Thermo Instruments Model 580 B photoionization detector (PID) for the presence of volatile organics.
